PEQUANNOCK RIVER, PASSAIC COUNTY

**COLD SPRING LAKE
DAM**

**PHASE I INSPECTION REPORT
NATIONAL DAM SAFETY PROGRAM**

AUGUST 1978

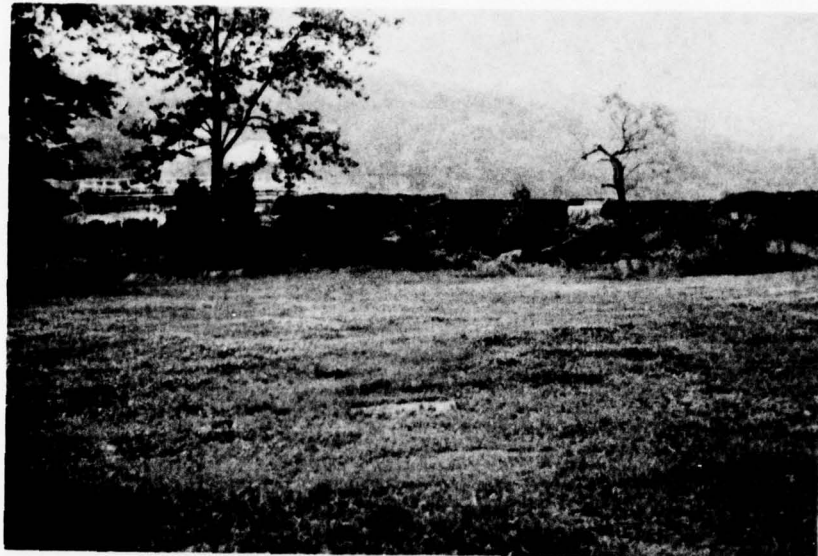
Photo 1 - Overall view of dam.

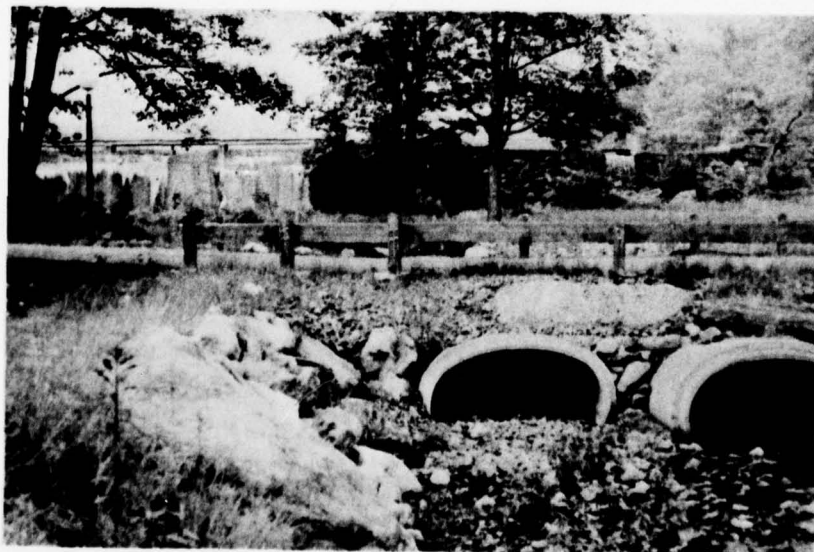
Photo 2 - Overall view of dam and culverts in discharge channel under private road.

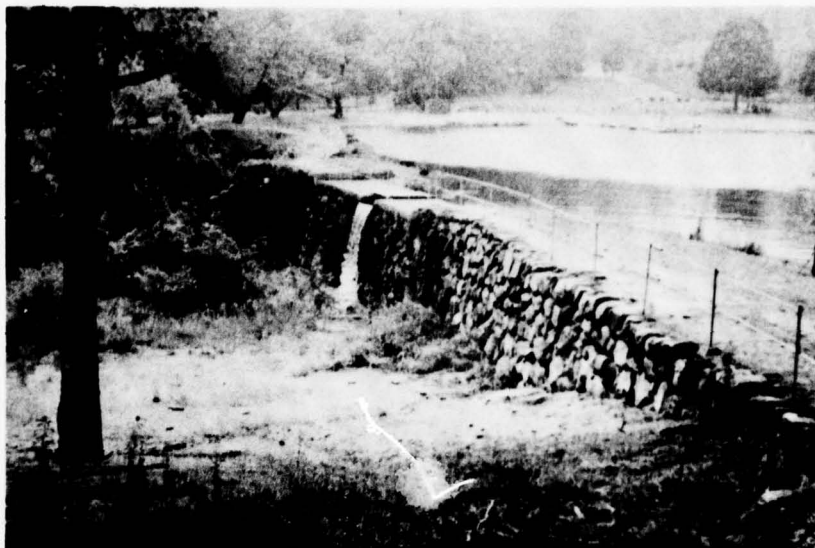
Photo 3 - View of dam from left abutment showing original rock masonry dam.

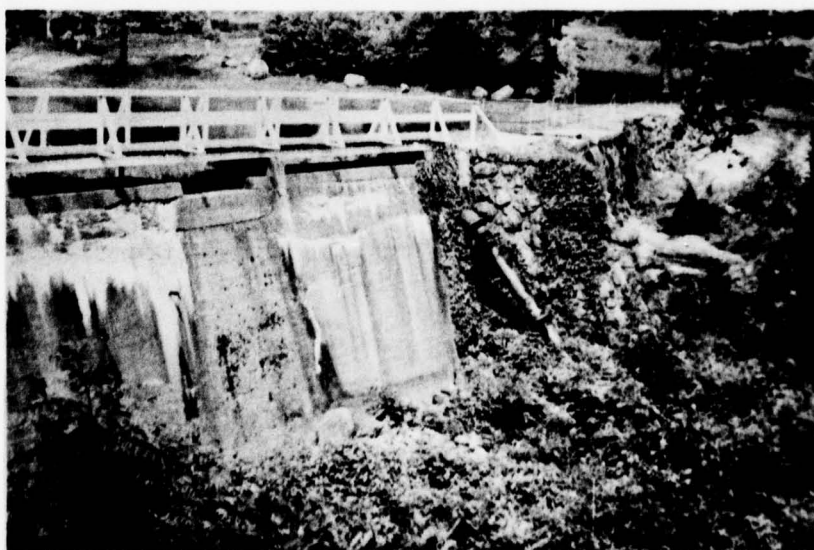
Photo 4 - View of dam from right abutment showing added concrete dam, spillway and abandoned cast iron pipe siphon.

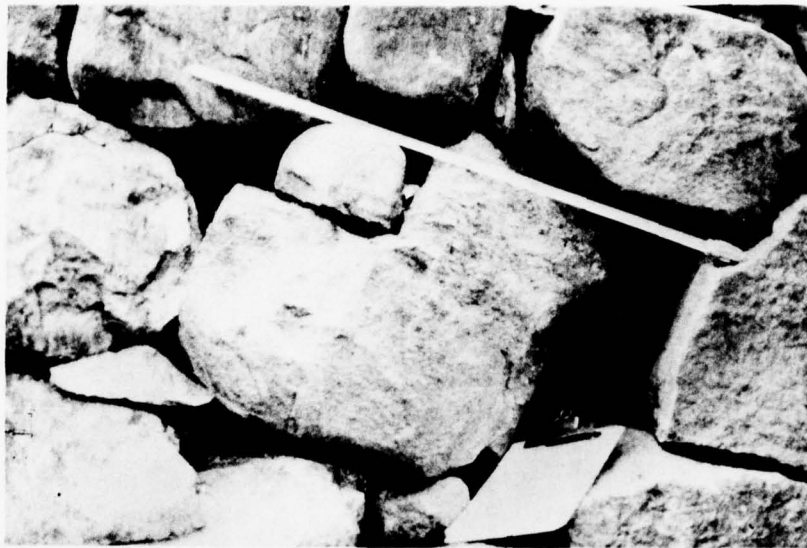
The rock masonry retaining wall appears to be in good condition. No evidence of settlement or movement was apparent. The stones in the wall are of hard, durable rock and show no signs of deterioration. No stones were displaced from the wall.

Photo 5 - Rock wall masonry of original dam.

c. No additional mortar should be added to the face of the masonry dam. Sealing the wall will alter the free draining characteristics of the wall and could allow for a build up in hydrostatic pressure at the back of the wall.

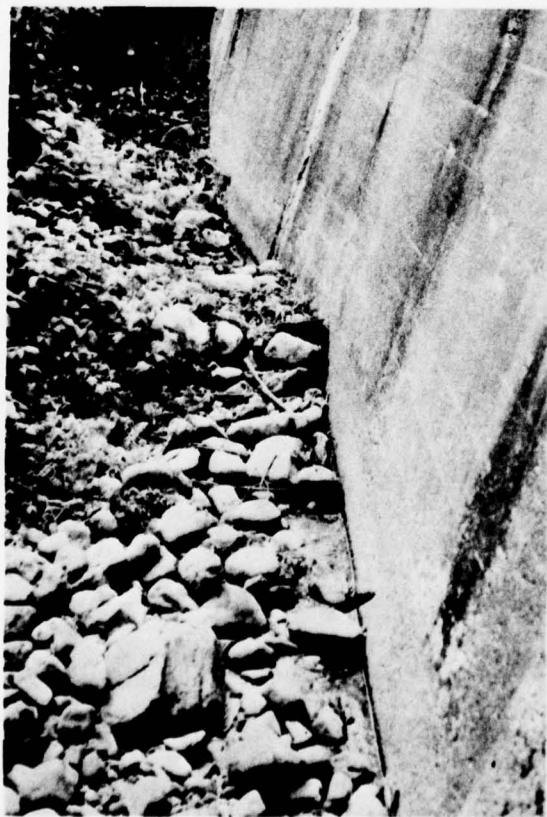
Seepage was observed flowing from beneath the apron at the base of the original section. Seepage was also observed immediately downstream of the concrete arch. In both locations the seepage appeared to be free of fine-grained soil (as well as coarse-grained soil). The seepage in the area of the concrete section was estimated at about 5 gpm. This seepage is believed to be occurring through the soil foundation under the section. No estimate of total seepage quantity could be made in the area of the original section due to discharge over the spillway. This seepage is believed to be occurring through both the embankment behind the wall and through the soil foundation under the dam.

Photo 6 - Seepage at base under
spillway of concrete dam.

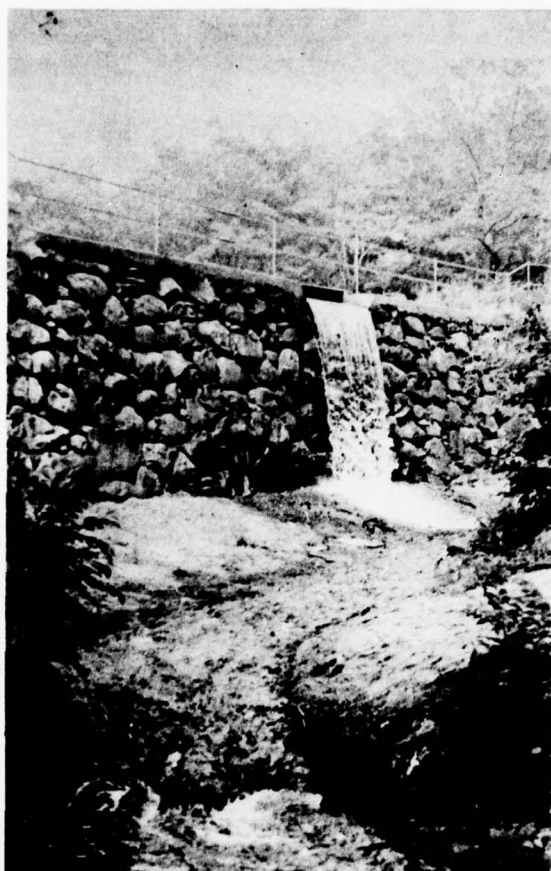
Photo 7 - Spillway in masonry dam.

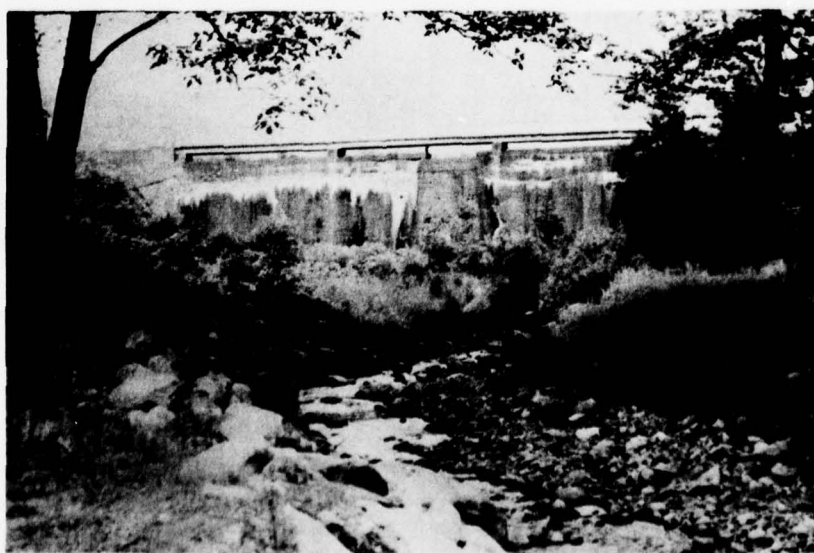
Photo 8 - View of spillway in concrete dam showing channel under spillway heavily covered with brush and vines. Discharge channel from masonry dam in foreground.

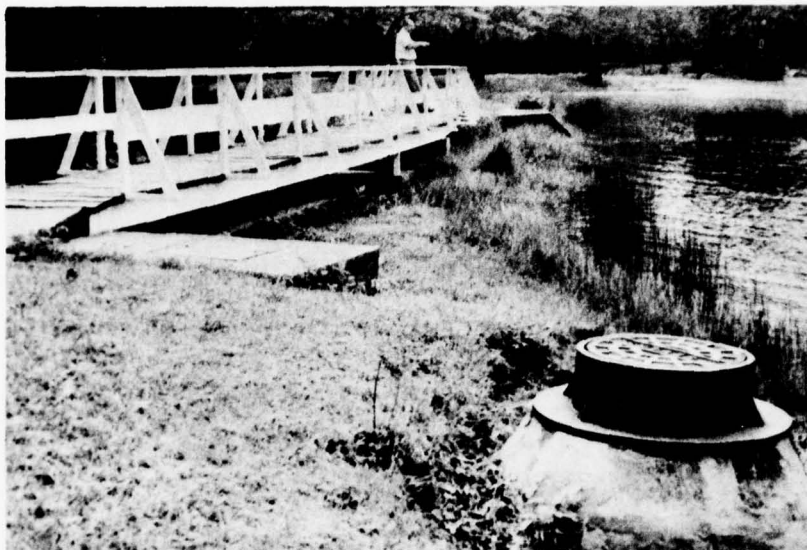
Photo 9 - Outlet valve chambers and footbridge over concrete dam spillway.

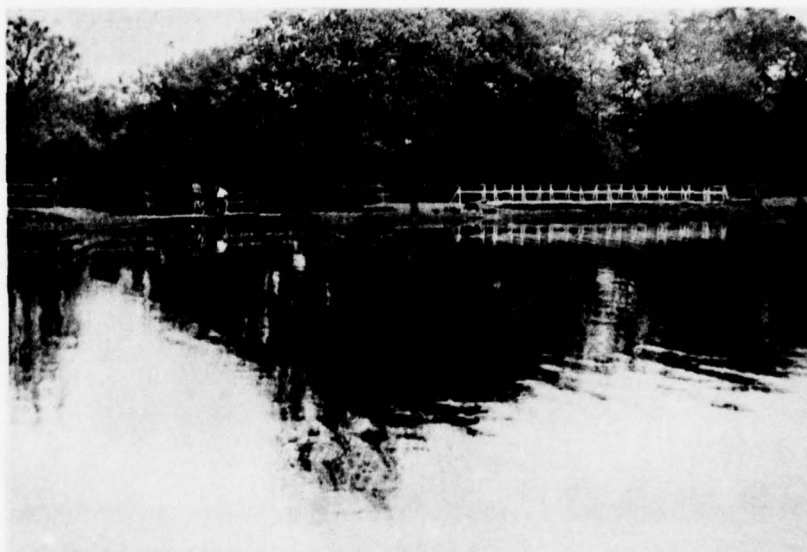
Photo 10 - View of spillways from upstream left shoreline.

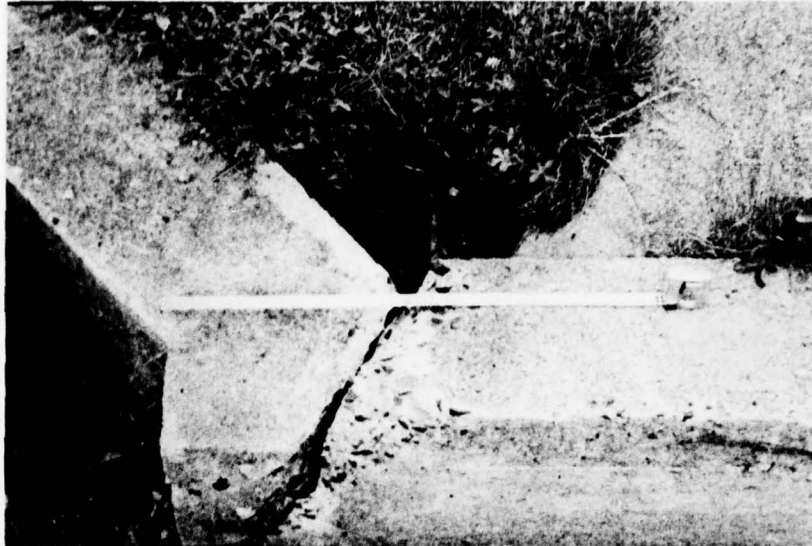
way has a lower central section for service discharges and a higher section on each side. The lower level spillway was discharging a small flow and was functioning very well. The crest of the weir is flat and extends over the full dam crest thickness. A small wooden footbridge was installed over the lower spillway notch. This bridge will probably be washed away if a large flow occurs over the upper level of the spillway. Erosion of backfill was observed behind the left wingwall of the spillway approach.

Photo 11 - Erosion and settlement of wingwall at left side of approach to masonry spillway.

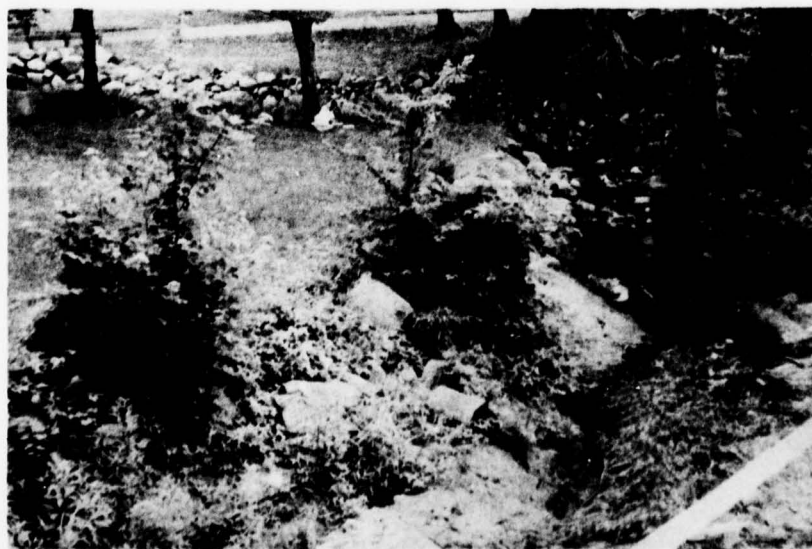
Photo 12 - Drainage channel for masonry spillway.

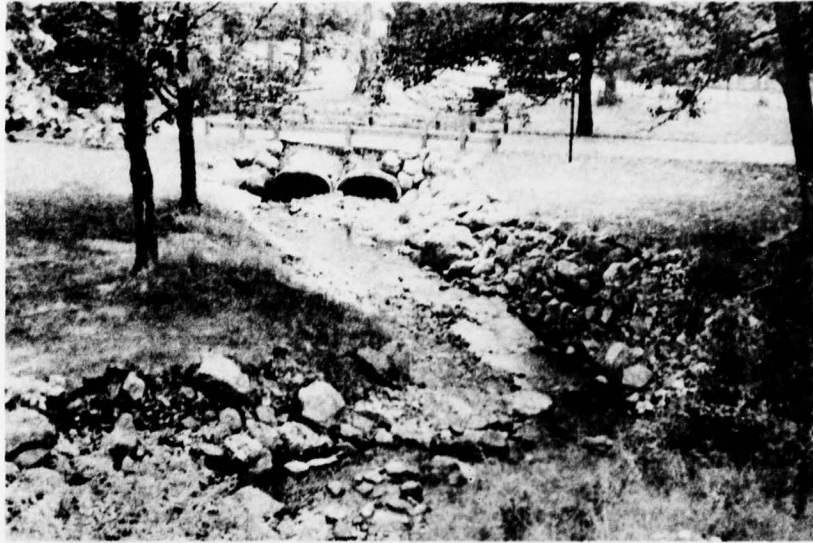
Photo 13 - Downstream drainage channel, private road, culverts and highway bridge in background.

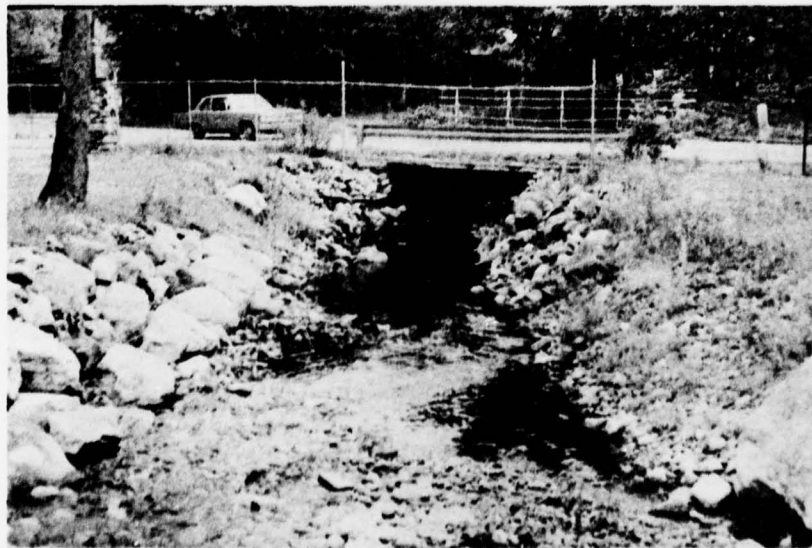
Photo 14 - Highway bridge under Macopin Road downstream of dam.

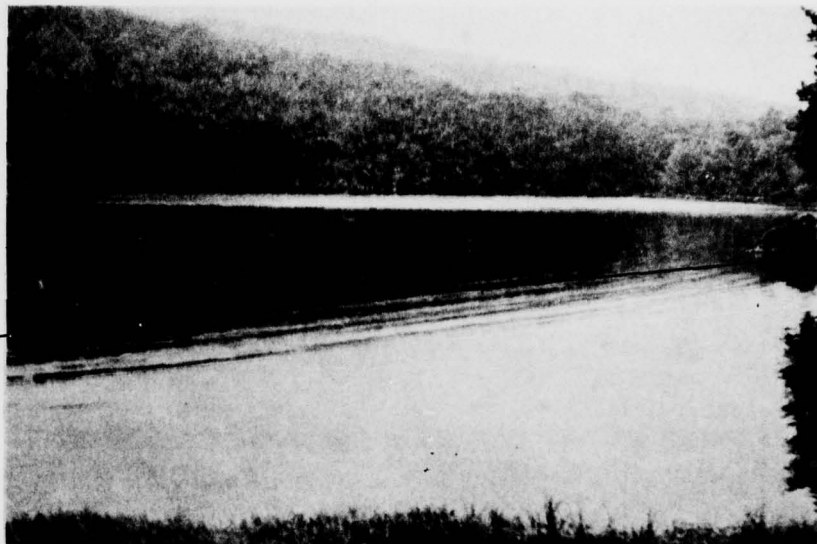
Photo 15 - View of Cold Springs Lake from near right abutment.
